## FIELD REPORT

<b>PROJECT:</b> Colchester Senior Center 15 Louis Lane Colchester, CT 06415	<b>FIELD REPORT No:</b> 18
<b>General Contractor:</b> BRD Builders LLC	<b>ARCHITECT'S PROJECT NO:</b> 20-003

**DATE:** 03/14/2024    **TIME:** 01:15 PM    **WEATHER:** Clear    **TEMP:** 61 degrees    **% COMPLETE:** 20%

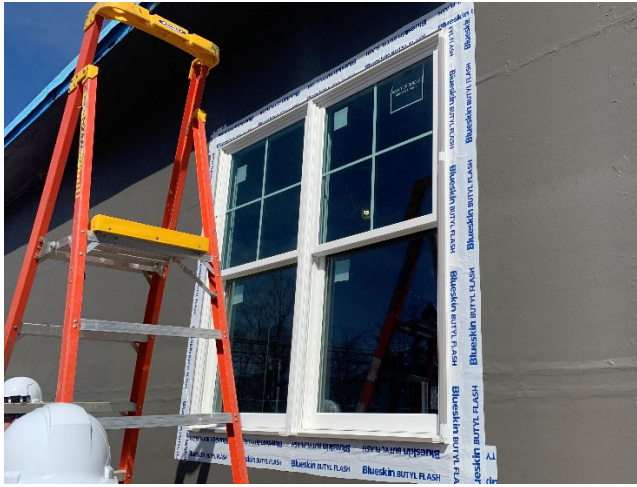
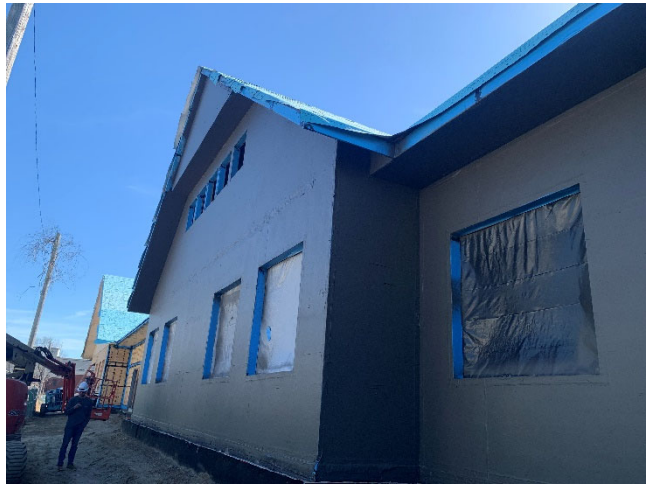
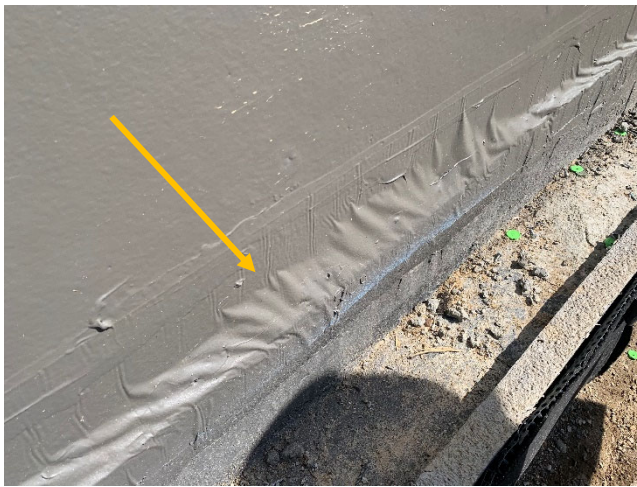
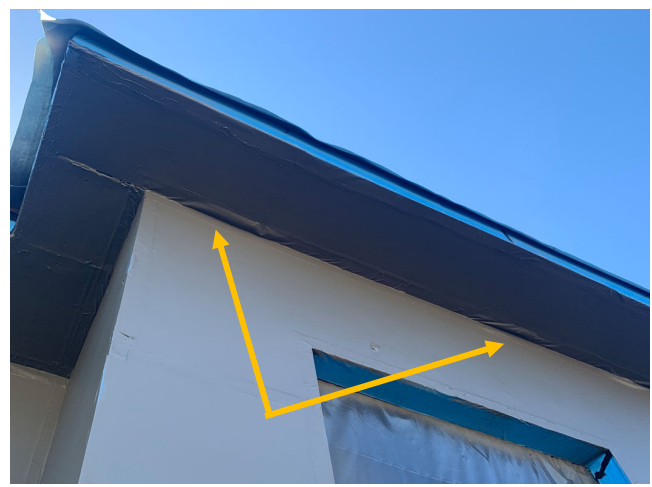
- It was observed that fluid-applied membrane application is in progress. Various areas will need to be corrected and replaced as there appear to be many air bubbles or voids below the fluid applied membrane that are possibly interfering with the contact and adhesion of the self-adhered flashing membrane to the building.

Examples of air bubbles or voids below the fluid applied membrane.
