## FIELD REPORT

<b>PROJECT:</b> Colchester Senior Center 15 Louis Lane Colchester, CT 06415	<b>FIELD REPORT No:</b> 18
<b>General Contractor:</b> BRD Builders LLC	<b>ARCHITECT'S PROJECT NO:</b> 20-003

**DATE:** 03/14/2024    **TIME:** 01:15 PM    **WEATHER:** Clear    **TEMP:** 61 degrees    **% COMPLETE:** 20%

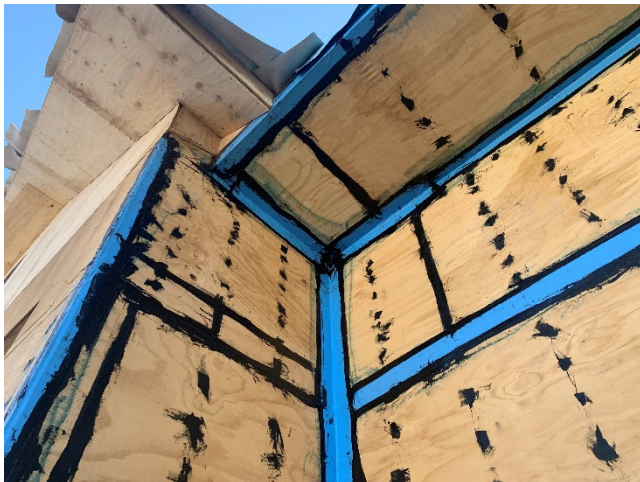
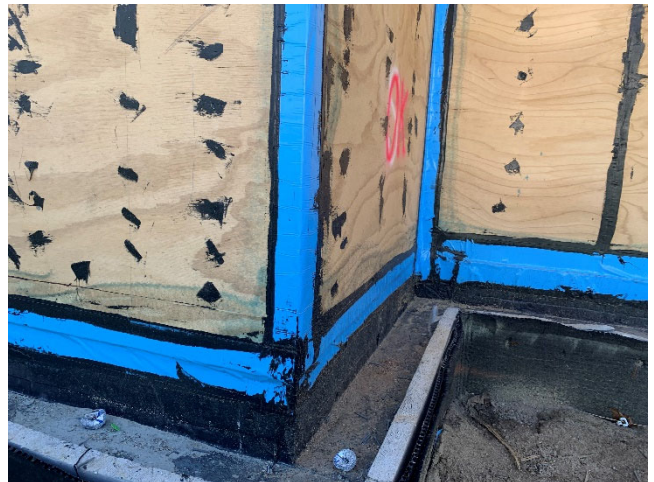
- It was observed that fluid-applied membrane application is in progress. Various areas will need to be corrected and replaced as there appear to be many air bubbles or voids below the fluid applied membrane that are possibly interfering with the contact and adhesion of the self-adhered flashing membrane to the building.

Examples of air bubbles or voids below the fluid applied membrane.
